# **Investigation Into the Effectiveness of**

# Efflorein

# in Minimising Efflorescence in Concrete

Report no 6810 (part 1)

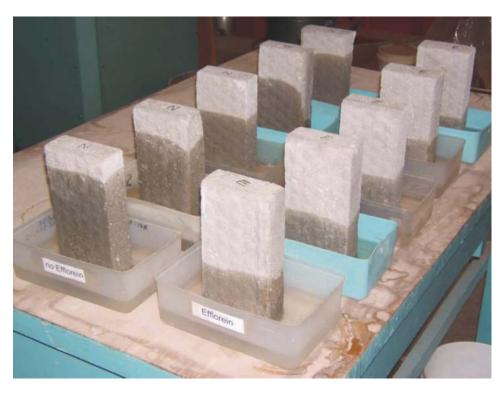
**Photo 1:** Control and Efflorein specimens after 18 hr in 1% salt solution

Water was observed to migrate up the specimens through the internal porosity until the rate of evaporation from the wet surface equalled the rate of uptake from the solution. This rate of uptake was nearly twice as fast in the control concrete as in the Efflorein concrete (see photo 1).

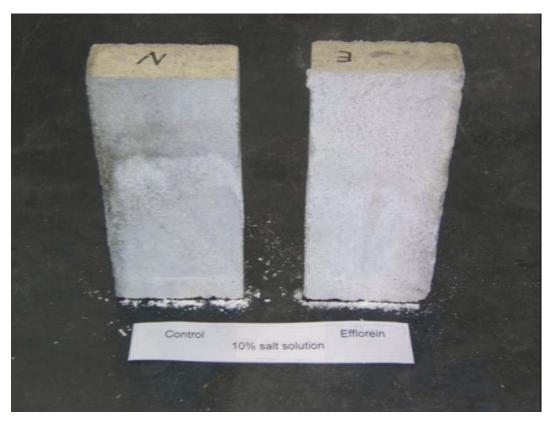
**Photo 4:** Specimens after 3 days in 10% salt solution, then air-drying

At both 0.1 and 1% salt concentration, significantly less efflorescence was seen in the Efflorein concrete (compared to the control) after the specimens had dried (photos 2 and 3). At 10%, the efflorescence was so great that it was difficult to make a quantitative judgement. Salt can be seen in photo 4 having fallen off the specimens onto the workbench.
